Mird Strike Testing of the Viggen Aircraft at the Holloman Mest Track, New Mexico, USA

hesented by Gösta Hiss, SAAB-SCANIA, Linköping, Sweden

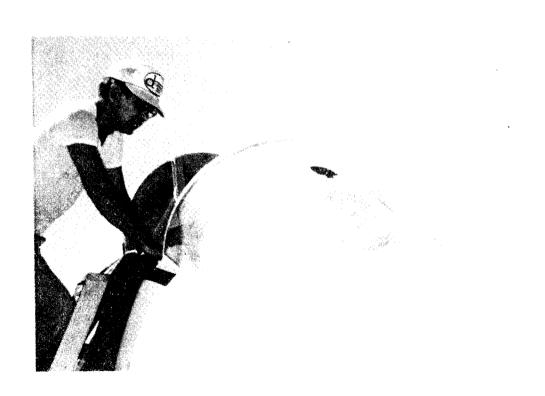
In our very first test we were aiming at 35 % of the energy curve value but due to somewhat higher bird weight we god 45 % and a big surprise. The bird punched a neat hole in the windshield: See figure 4 and 5. From there on we decided to use only 1 kg (or 2 lbs) birds. Starting from roughly the same energy by using a low impact speed, the energy was increased in steps until we finally reached 100 % without any further holes.

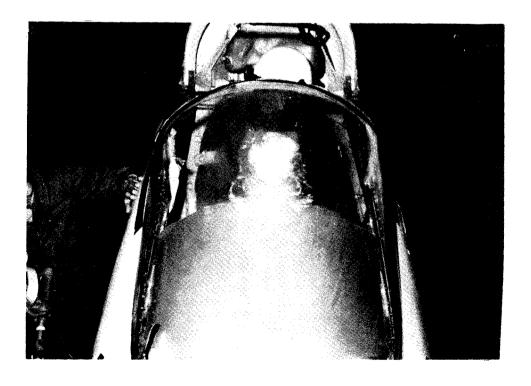
Figure 6

In the last test, however, a lot of the surface was eroded away as seen in the picture figure 6.

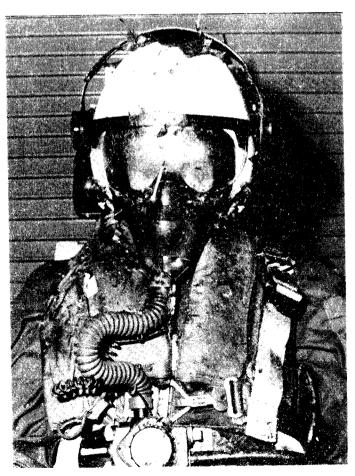
Pigure 5

In the last two tests we found that the canopy although it withstood a direct hit of a 0.8 kg bird at 700 km/h, it broke as a result of the hit in the windshield. This is due to the fact that the windshield deflexion presses down the arc which permits bird mass to get under the rim of the canopy and enter the cockpit. This spray of birdmass breaks the canopy and hits the dummy. It is however shown that the dummy/pilot should survive as the inner visor of his helmet is intact. See figure 3.

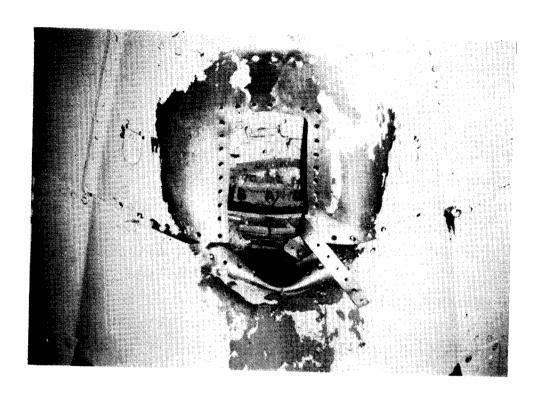
Figure 9

The hit in the structure in front of the windshield produced a hole (see figure 9) but the bird mass was effectively stopped by the reinforcement from entering the cockpit.
