Regulation and Compliance

ICAO Standards and Recommended Practices

ICAO Annex 14

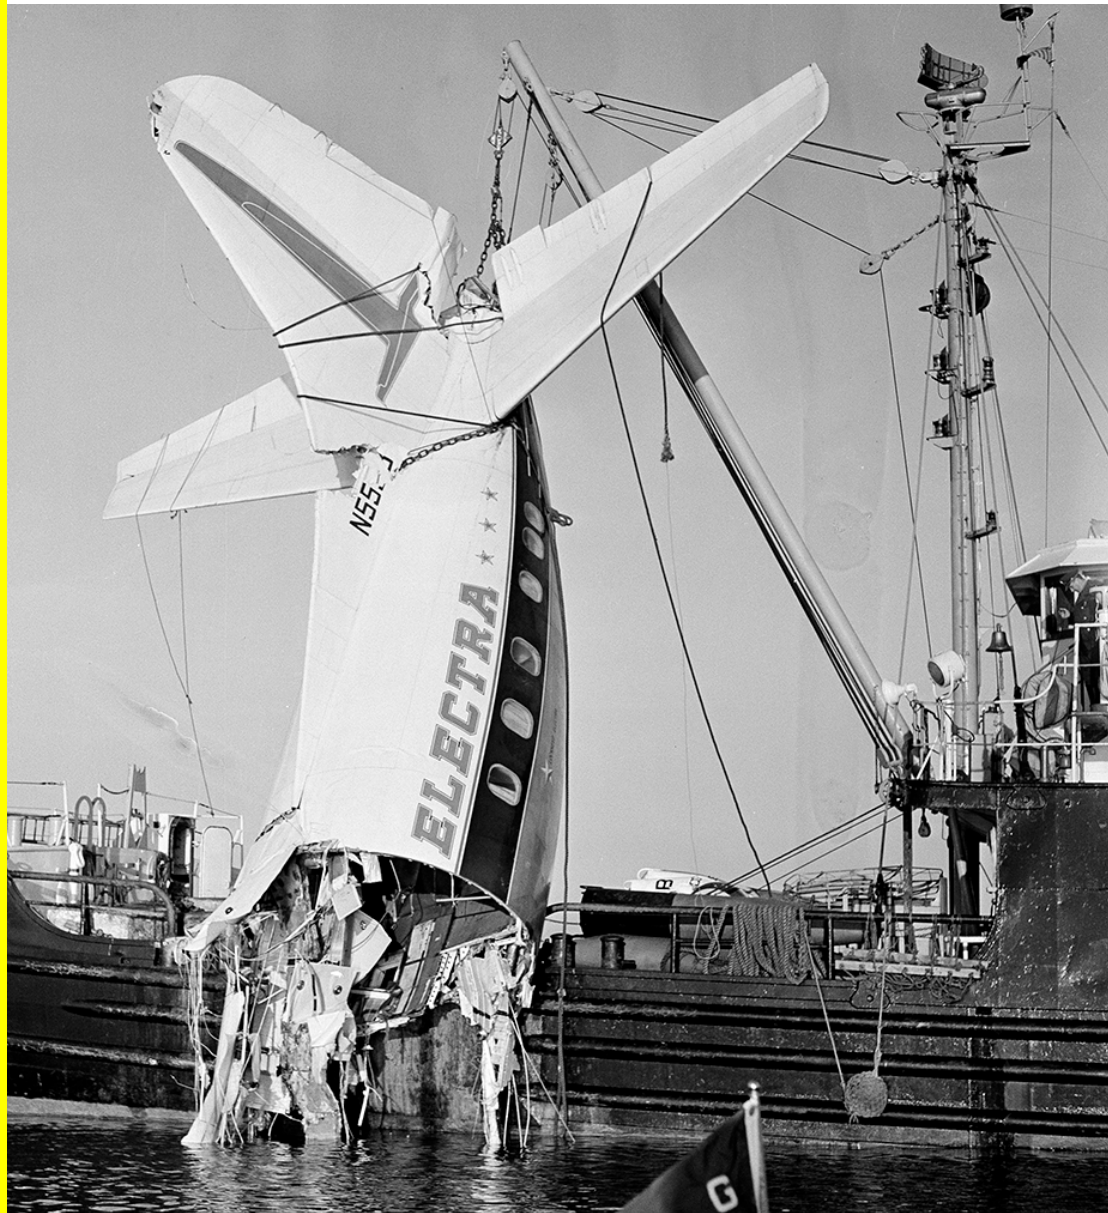
There were already concerns about the Electra's structural integrity after two disintegrated in flight, the cause being flutter from the outer engine nacelles

Passengers reported seeing a 'dark smudge' that 'passed through the propeller arc' before the aircraft crashed into Winthrop Bay and the fuselage split into two pieces which sank into the mud 600 yards from shore

As a result of the Electra crash, new safety standards for engines were introduced, and problems of birds at airports were examined further.

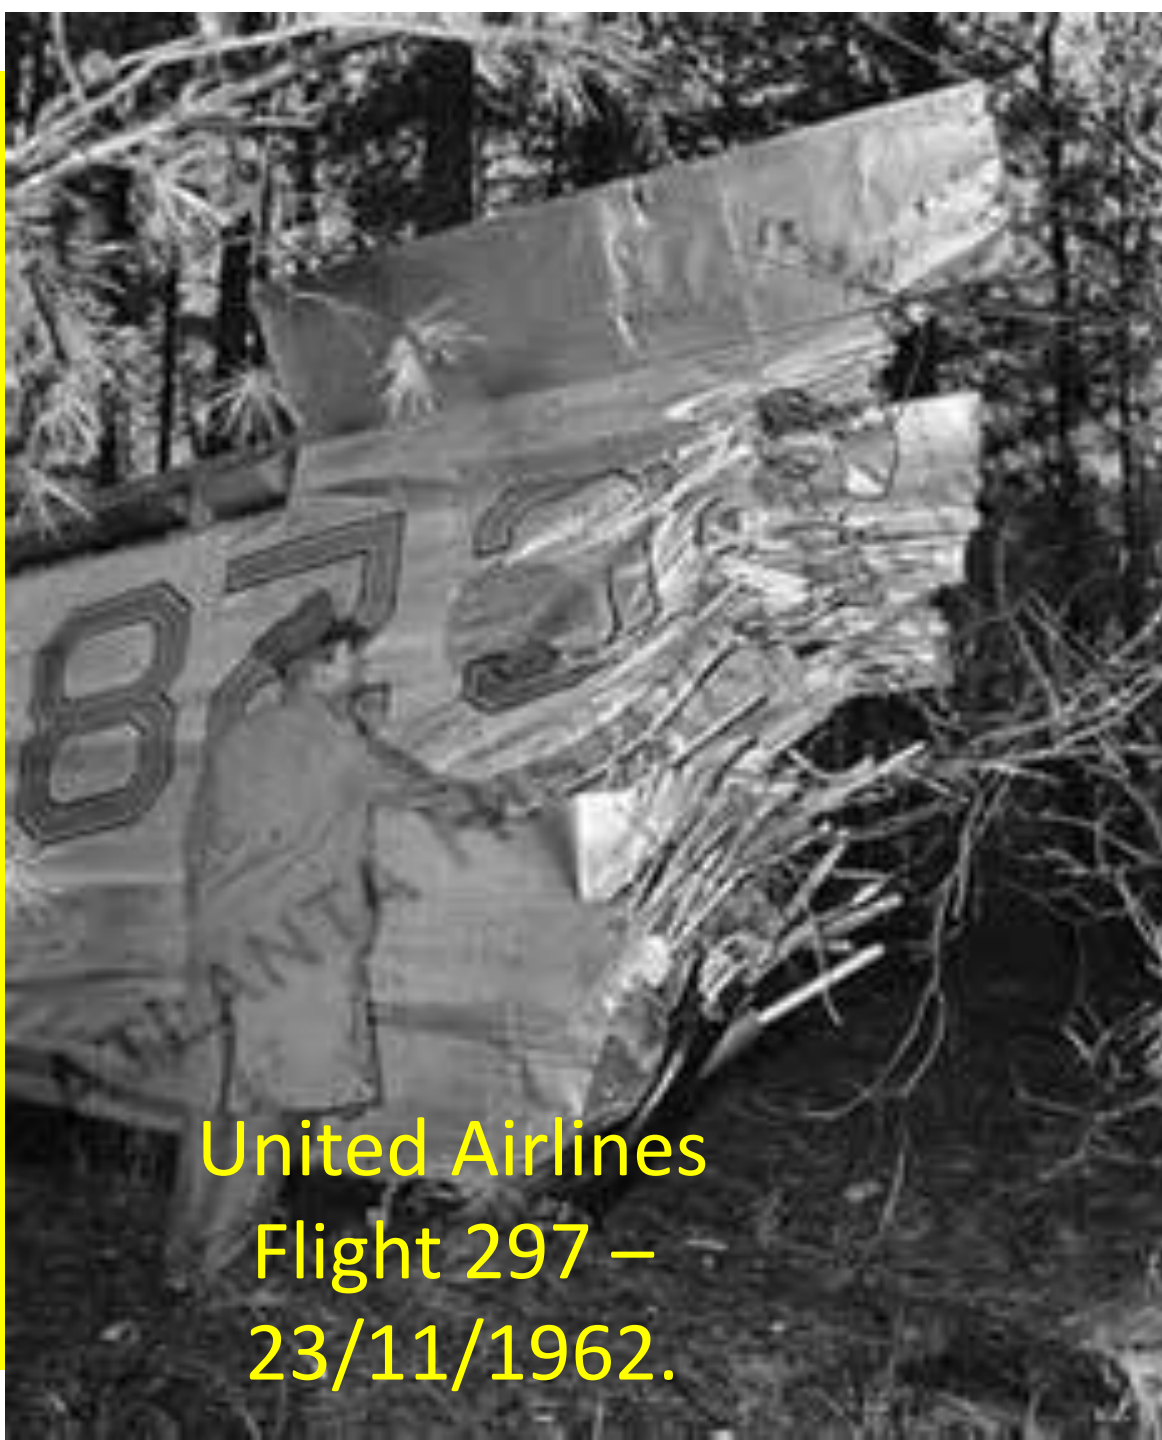
**United Airlines
Flight 297 –
23/11/1962.**

Aircraft was operating at its assigned altitude of 6,000'. ATC advised '... there's been numerous reports of considerable amounts of ducks and geese around this area'. The crew acknowledged this and five minutes later the aircraft two Whistling Swans hit the aircraft. One caused superficial damage. The other punctured the left horizontal stabilizer, travelled through that and damaged the elevator as it exited. The structure was so weakened that it failed completely, making the aircraft uncontrollable. It crashed from 6,000' killing the crew and passengers.

As a direct result of this crash, aircraft tail areas were required to withstand impact with a 3.7 kg bird.

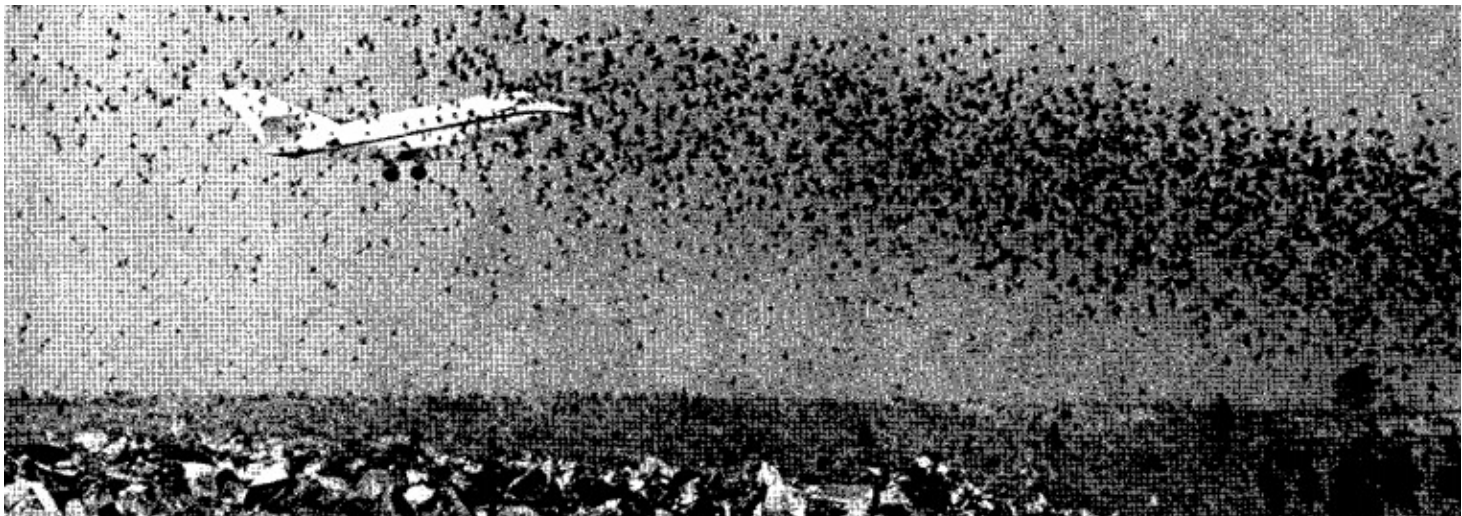
Norwich Airport, United Kingdom

Fan Jet Falcon – Fred Olsen Airtransport Ltd – 12/12/1973.

The Falcon with two crew and six passengers began take-off at 15.37 local. Just as they became airborne half way down the runway, they saw birds. Just above the ground. The co-pilot increased the climb rate but then saw another flock of birds directly in their path. He lowered the nose and the aircraft passed underneath them. However, at around 150' agl they saw another flock which was both below, ahead and above them. Unable to avoid them, there was a multiple bird-strike. The engine rpm wound down and speed dropped from 150 knots to 135 knots. To maintain air speed the Captain lowered the nose. A forced landing was made in a field directly ahead of them. They missed trees at the edge of the field but tore off the undercarriage legs. Once again, the controllers were not found liable as that part of the airfield was not visible from the tower. The bird management personnel had previously advised getting better equipment, but this was turned down.

During subsequent litigation, Mr Justice Tudor Evans said that an 'inadequate inspection system and haphazard and lax attitude to bird control were entirely to blame for the forced landing.

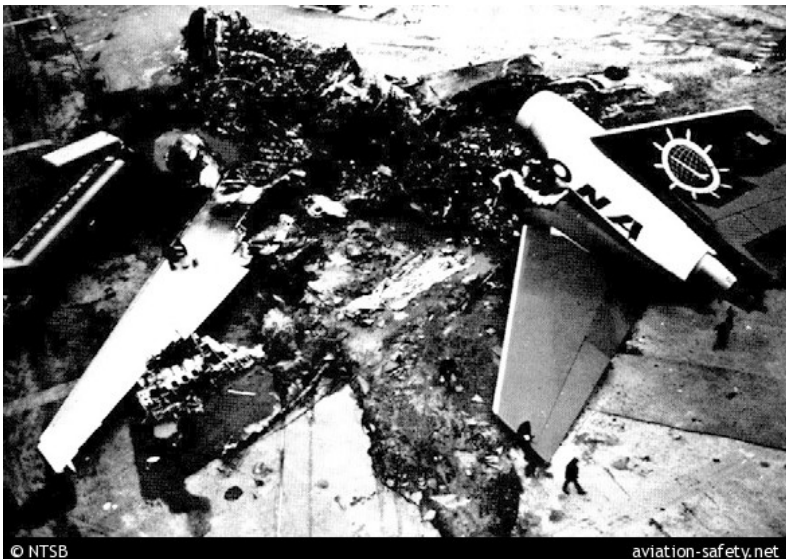
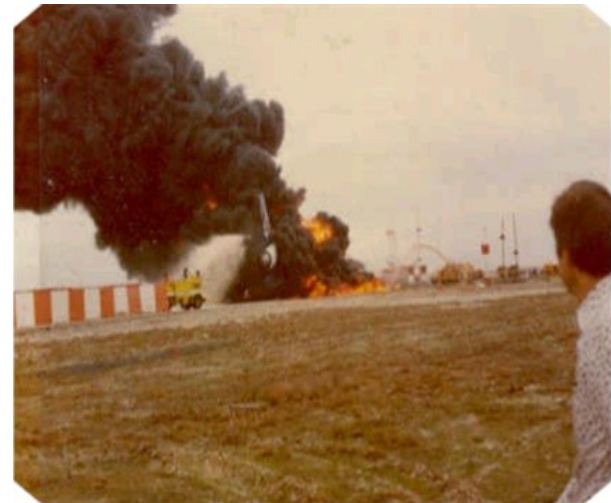
ONA DC10 and Air France Concorde

The DC10 was taking off from JFK when gulls were ingested into the right engine. The pilot aborted the take-off and tried to decelerate, but the number 3 engine exploded. Heavy braking blew the tyres, the right undercarriage collapsed and then the right wing was torn off. The aircraft skidded for several hundred metres, finally stopping in soft mud near the end of the runway. With a full fuel load, the aircraft caught fire and was destroyed. By luck, all of the passengers were airline employees and knew how to exit an aircraft in an emergency. Only 30 suffered any injuries. The NTSB report noted that 'the bird control programme at JFK did not effectively control the bird hazard at the airport'. A complex legal battle followed, involving the aircraft owners (the Bank of America), ONA, FAA, Port Authorities of New York and New Jersey, New York City and several aviation companies. **The city was involved because there were two landfill sites near the airport which could have attracted birds. Settlement was finally reached in 1985, nine years after the accident.**

An Air France Concorde ingested Canada Geese while landing. The birds were ingested into the number 3 engine, which suffered an uncontained fan failure. Shrapnel from this engine destroyed the number 4 engine and severed control and hydraulic lines. **The French Aviation Authority sued the Port Authority of New York and New Jersey. This was eventually settled out of court for \$5.3 million.**

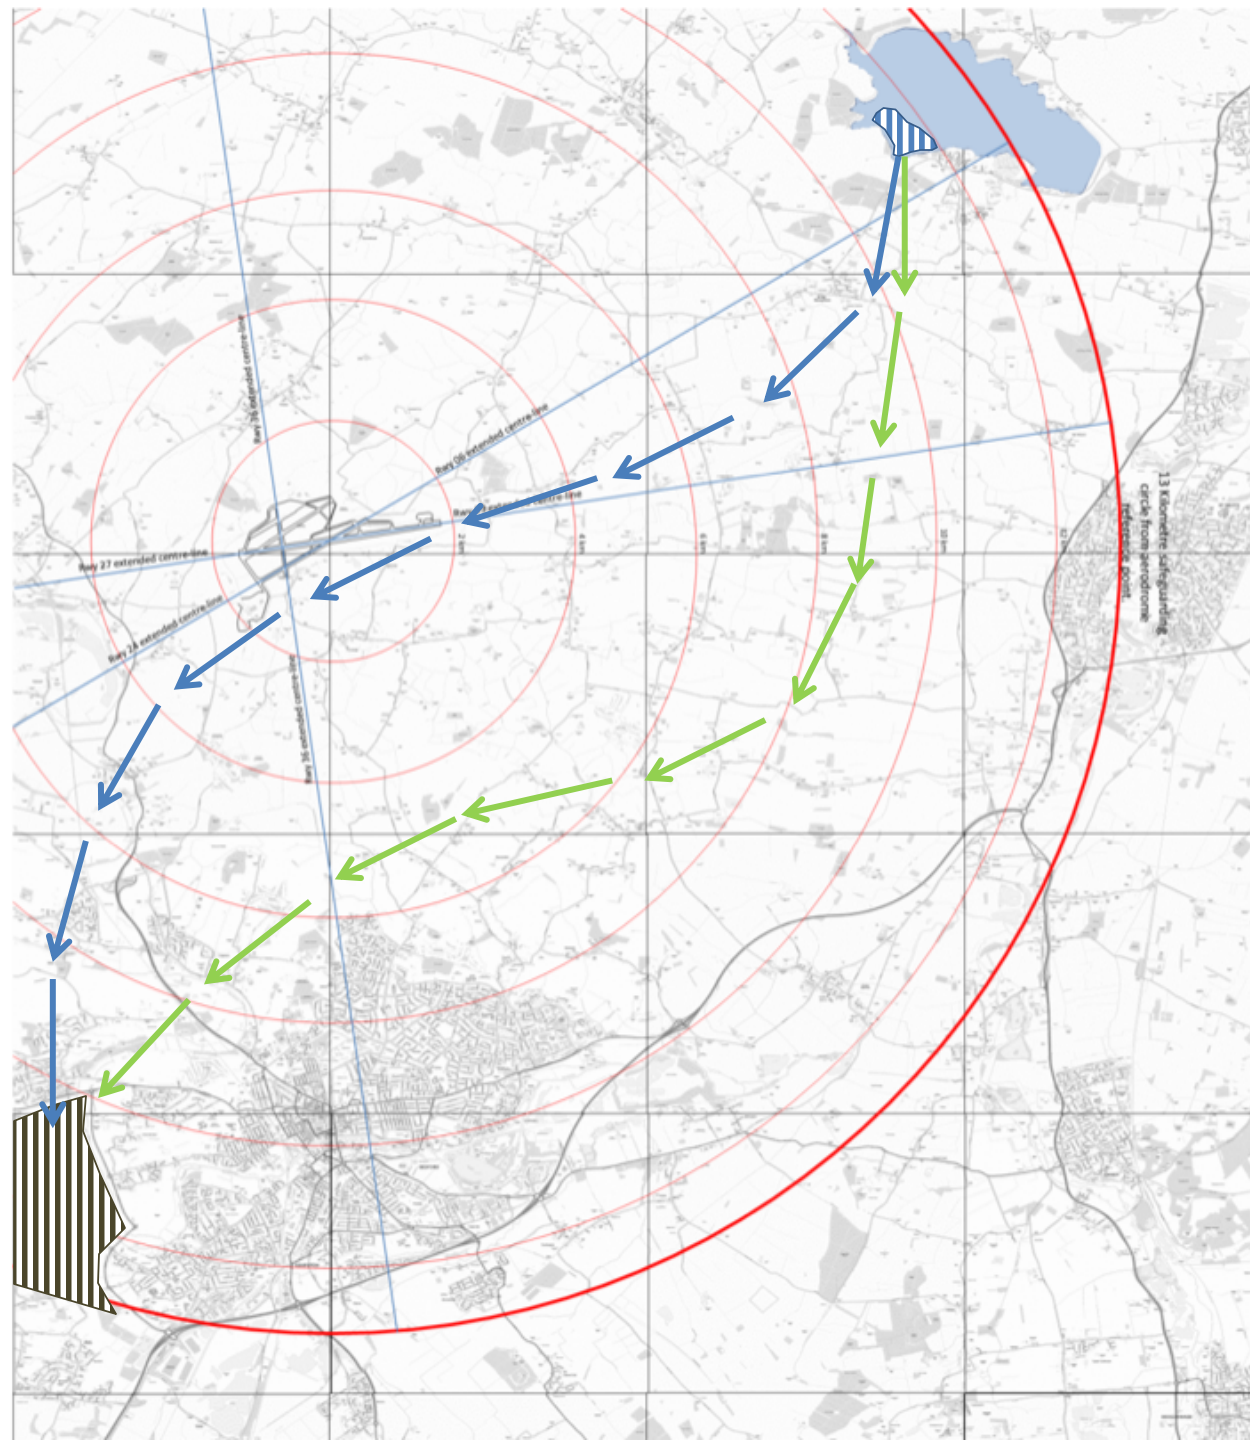
CAP 738 – 13 km Safeguarding Circle

The UK CAA require that each licenced aerodrome produces a 13 kilometre safeguarding circle.

In practice, few seem to understand that this is **not always** a simple circle. If the runway is greater than 1800 metres in length, then this will elongate the circle into an oval.

The zone is based on a statistic that 95% of bird strikes occur below 2000ft, and that an aircraft approaching an aerodrome on a normal approach would descend below 2000ft approximately 13km from the runway.

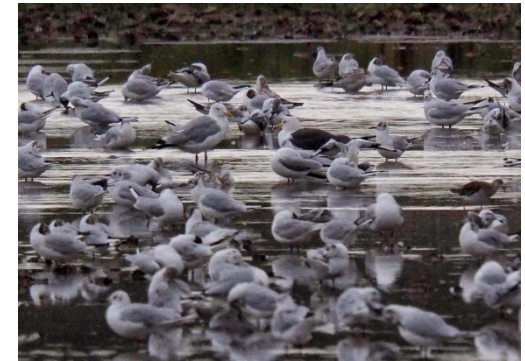
Grafham Water Reservoir Gull roost > 10,000 Black-headed Gulls

1980 daily migration route

1991 daily migration route

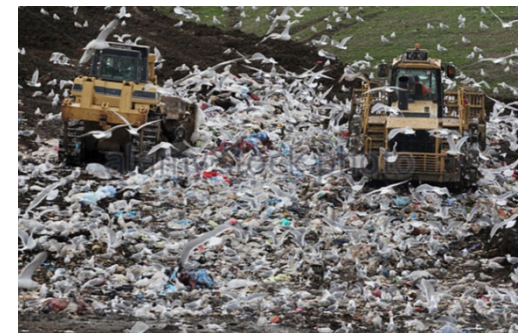
Stewertby Landfill Site
Gull feeding area
