Mird Strike Testing of the Viggen Aircraft at the Holloman Mest Track, New Mexico, USA

hesented by Gösta Hiss, SAAB-SCANIA, Linköping, Sweden

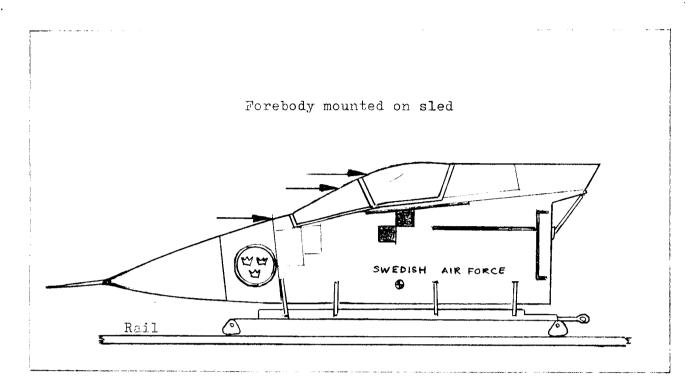
Figure 1

The windshield is made of stretched acrylic 23 mm thick and has a single curvature with a radius of 400 mm. In the test-condition with the "aircraft" centerline parallel to the rails, the impact angle was 28 and the impact point 2/3 up the centerline of the windshield. See figure 1.

The canopy has double curvature and in mode of the same noterial 10 mm thick. The impact point was on the centerline 100 mm aft of the front arc which gave an impact angle of 22.5°. See figure 1.

The impact angle was 17° on the centerline in the joint between the radom and the forebody. See figure 1.
